NASA TM X-64510

**A STRESS CORROSION EVALUATION OF
AISI - H-11 ALLOY STEEL PLATED
WITH NICKEL-CADMIUM COATING**

By J. W. Montano
Astronautics Laboratory

April 2, 1970

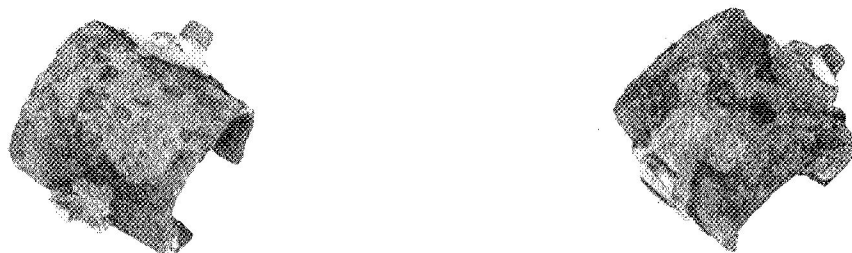
FIGURE 12

H-11 ALLOY STEEL ULTIMATE TENSILE STRENGTH 240 KSI
BARE "C" - RING SPECIMENS
STRESSED TO 25% OF THE 0.2% YIELD STRENGTH
EXPOSED TO 180 DAYS OF ALTERNATE IMMERSION TESTING

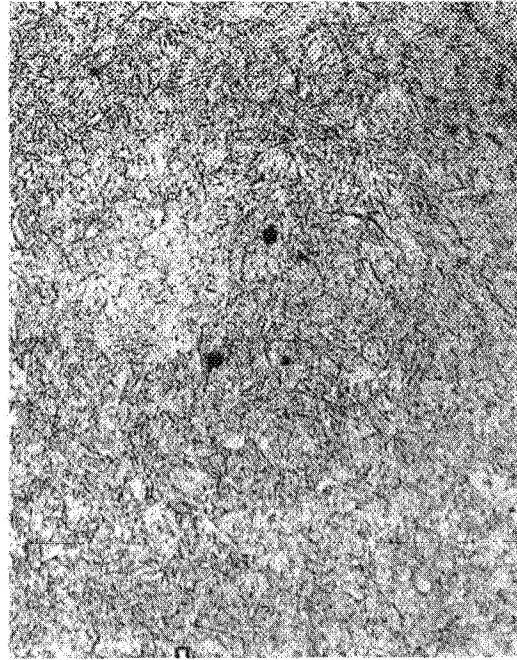
**FIGURE 19-MICROSTRUCTURE OF H-11 ALLOY STEEL
Nital Etch 425X Mag**

The tensile test results are tabulated in Tables II and III and are presented graphically in Figures 2 and 3. The "C"-ring stress corrosion test specimen configuration and the tensile test stress corrosion specimen configuration are illustrated in Figures 1a and 1b. Actual stress corrosion test samples are illustrated in Figures 4-18. Photomicrographs are presented in Figure 19.
